Summary of North Carolina's experience with Safety Edge.

# **North Carolina Implementations**

Pilot Projects Implemented over the Last Several Years

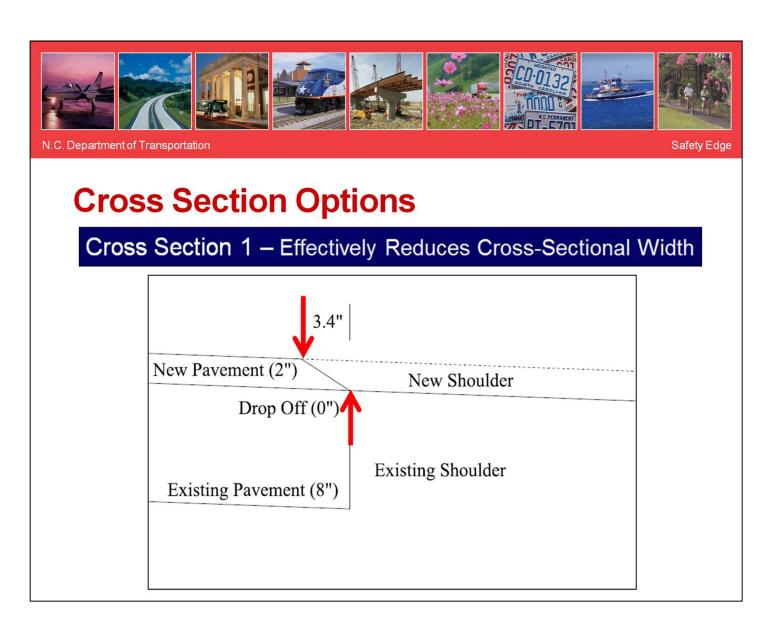
The Cross Section 1 above represents when the toe of the wedge is placed at the old edge of pavement and the breakpoint of the wedge is 3 to 5 inches in from the old edge of pavement (distance dependent on the thickness of the lift). This places the entire edge shape over existing pavement which effectively reduces the existing cross-sectional width of the new pavement lift.

Cross Section 1 represents what North Carolina did in some of the 2008 through 2010 projects.

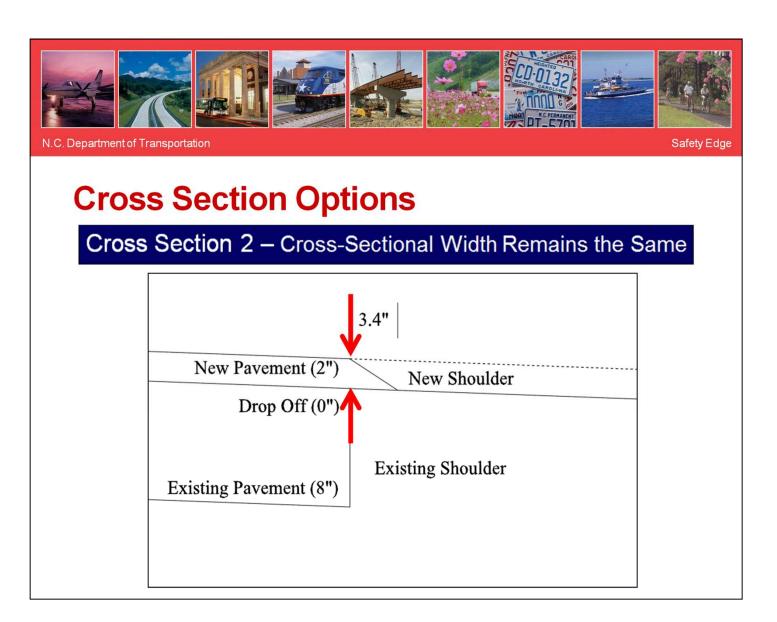
The Cross Section 2 above represents when the breakpoint of the wedge is placed at the old edge of pavement and the toe of the wedge is 3 to 5 inches out from the old edge of pavement (distance dependent on the thickness of the lift). This places the entire edge shape over soil <a href="which effectively keeps the existing cross-sectional width the same on the new pavement lift as the old pavement lift.">which effectively keeps the existing cross-sectional width the same on the new pavement lift as the old pavement lift.</a>

Cross Section 2 represents 90 percent of what North Carolina did in the 2011 Projects.

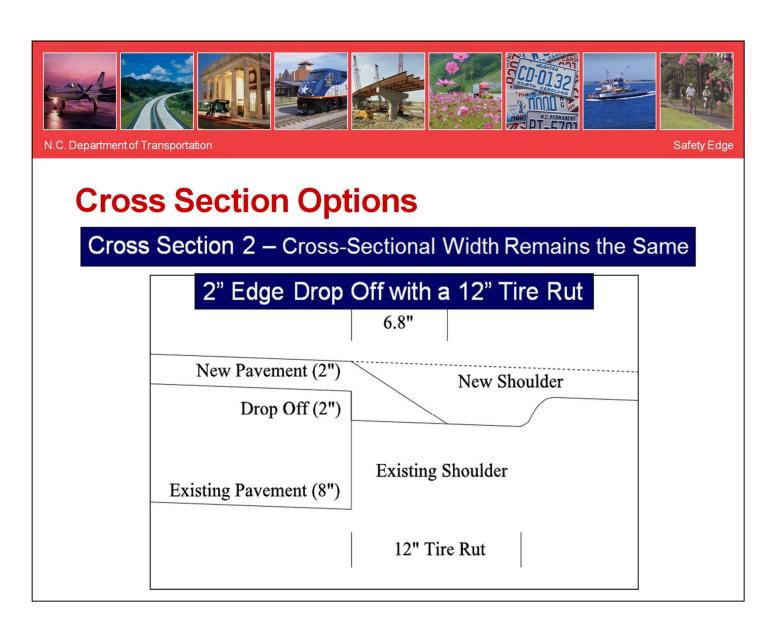
The Cross Section 2 above represents when the breakpoint of the wedge is placed at the old edge of pavement and the toe of the wedge is 3 to 5 inches out from the old edge of pavement (distance dependent on the thickness of the lift). This places the entire edge shape over soil which effectively keeps the existing cross-sectional width the same on the new pavement lift as the old pavement lift.

This slide represents what would occur if there was an existing 4 inch edge drop-off. The edge would extend out an additional 6.8 inches on a 2 inch lift (distance is increase from 3.4 inch increase when there is no edge drop off). Keep in mind that the edge devices make a safety edge shape that is 6 to 9 inches wide (dependent on device). For this example of a 10.2 inch safety edge shape (from a 4 inch edge drop-off), the 9 inch safety edge device would only make the shape for the first 9 inches after the edge breakpoint, then the asphalt would fall off as usual. This will be demonstrated in multiple photos throughout this section.

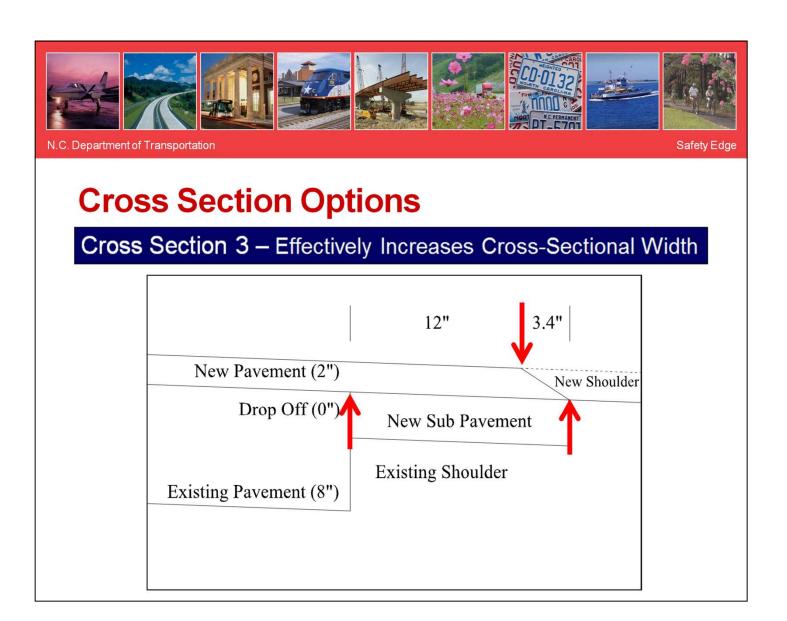
The Cross Section 3 above represents when the toe of the wedge is placed at the edge of the new sub pavement and the breakpoint of the wedge is 3 to 5 inches in from the edge of the new sub pavement (distance dependent on the thickness of the lift). This places the entire edge shape over new sub pavement which effectively increases the existing cross-sectional width of the new pavement lift (distance dependent on the amount of paved shoulder increase within the specific project).

Cross Section 3 represents 10 percent of what North Carolina did in the 2011 Projects.

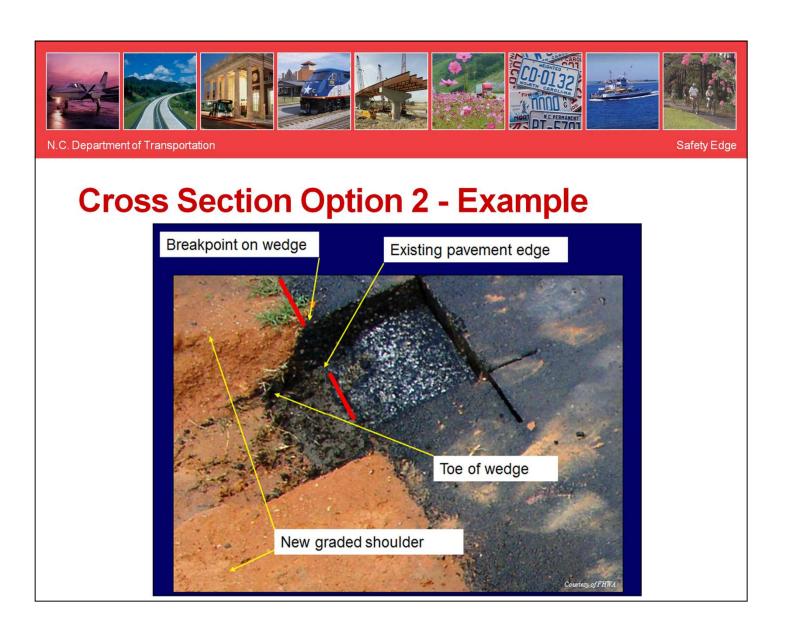
Cross Section 2 Example from Georgia Installation. Edge was placed on dirt.

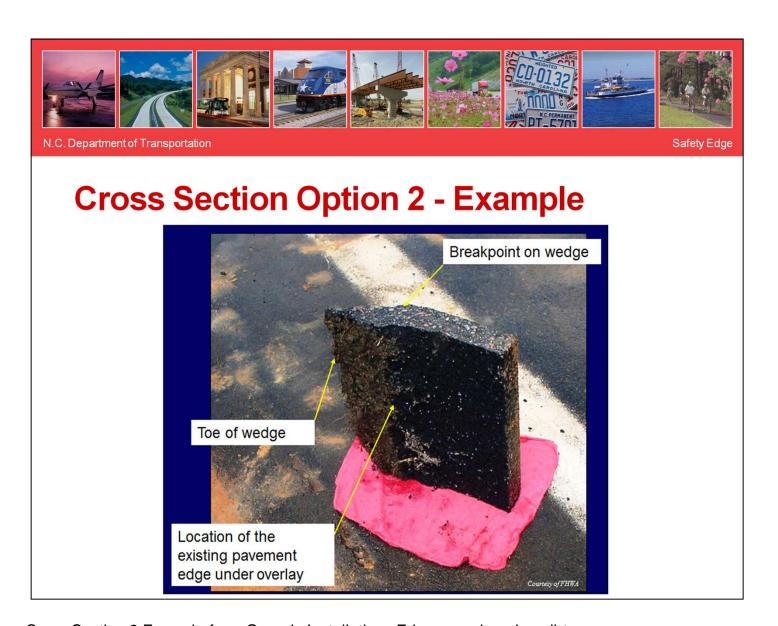
Cross Section 2 Example from Georgia Installation. Edge was placed on dirt.

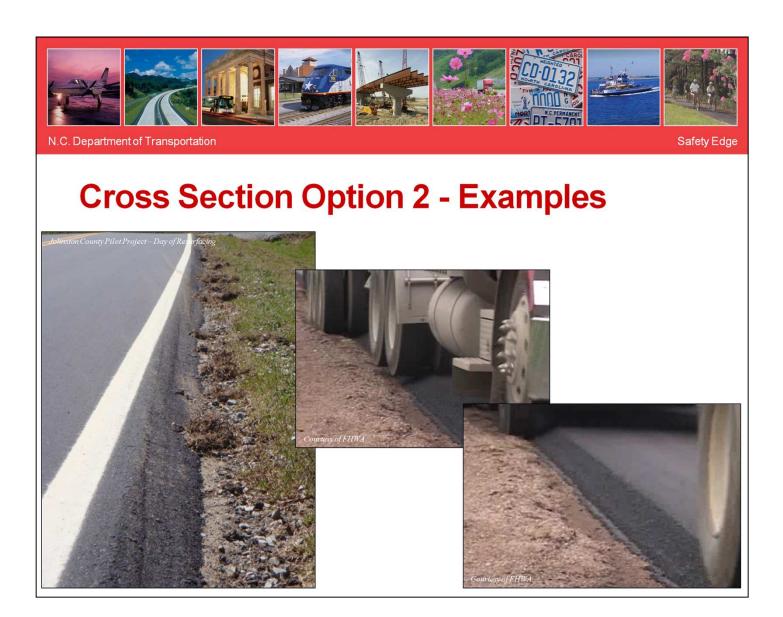
Picture on left is from third Johnston County Pilot Project Implementation where the asphalt trucks had to drive around the Paver shortly after this section of roadways Safety Edge was laid. Photo on right is from Georgia installation. Both of these edges were placed on dirt.

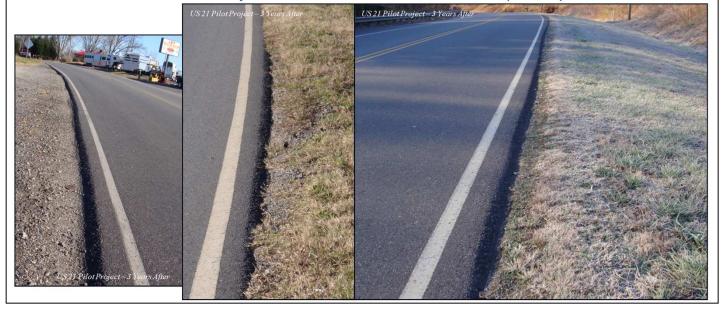
Proven durability under heavy truck usage from three (3) year observational analysis of an ~8 mile section of road (US 21)

These photos represent the three (3) year after observation of the Safety Edge installation on US 21.

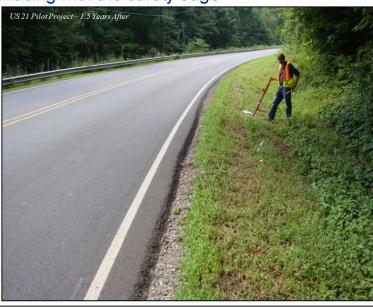
Where shoulder rutting occurred prior to resurfacing, the same shoulder rutting occurred after resurfacing with the safety edge

This location is an example of where shoulder rutting existed six (6) months prior to the resurfacing job (right). The left photo shows the same location re-rutted one and one half (1.5) years after the resurfacing job.

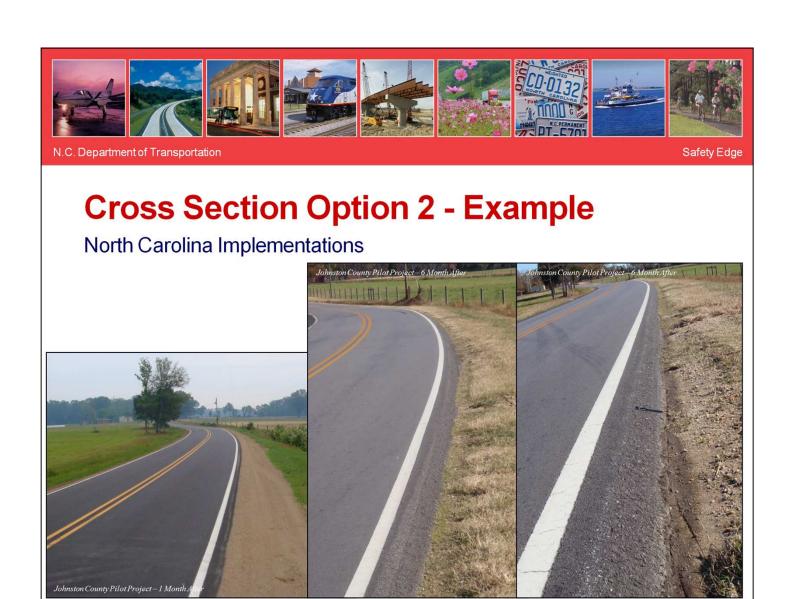
This location is an example of where the shoulders were pulled back one (1) month after Safety Edge implementation and how the same edge looked at the six (6) month observation. This specific curve was heavily rutted out prior to the resurfacing.

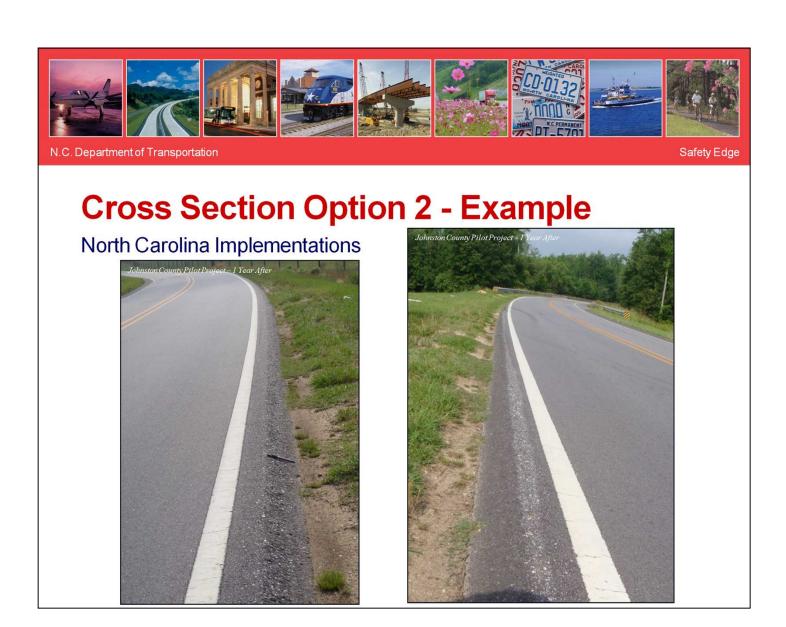
One (1) Year After Observation.

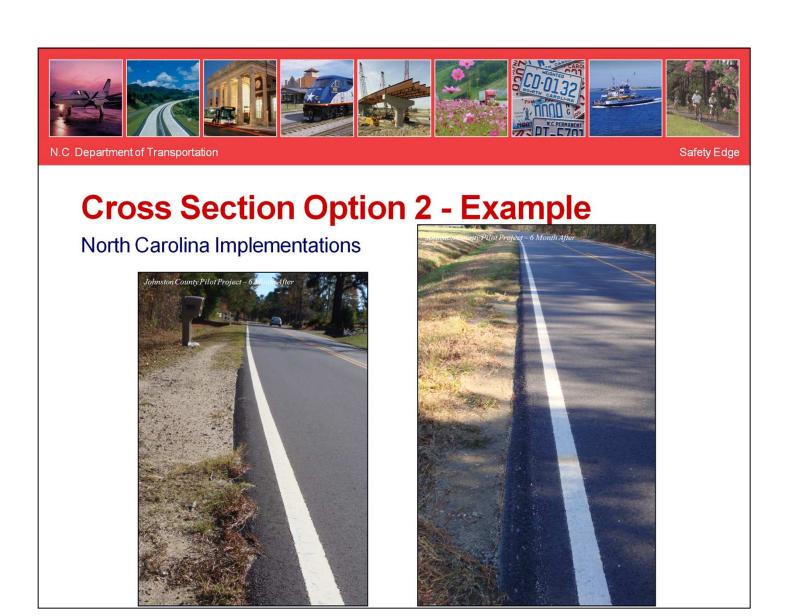
Six (6) Month After Observation.

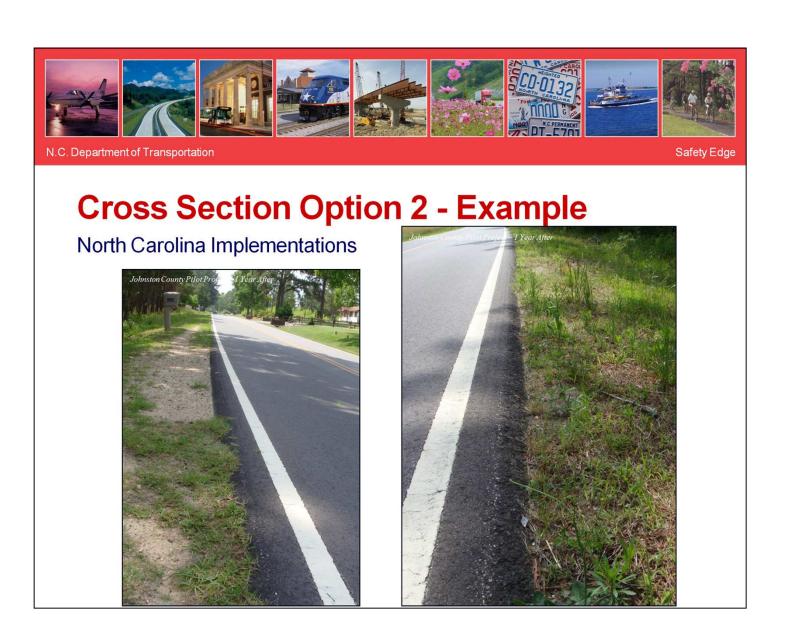
One (1) Year After Observation.

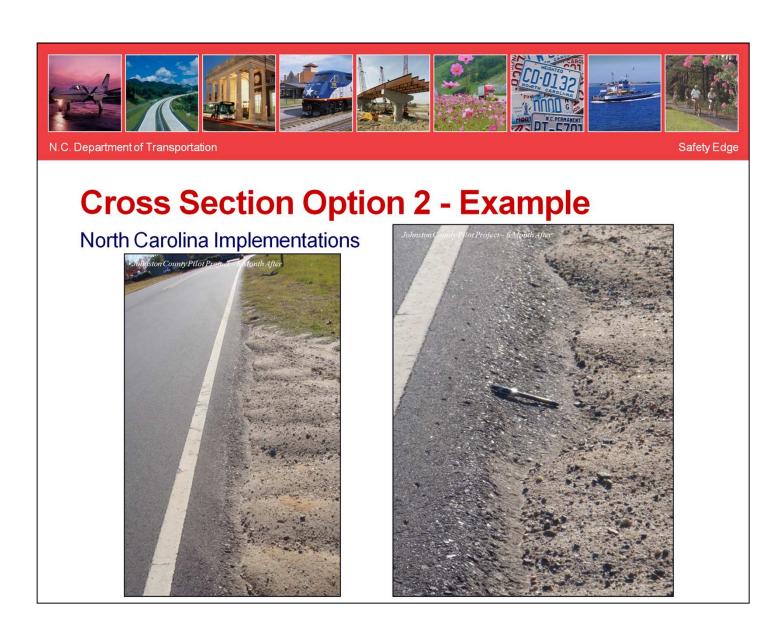
Six (6) Month After Observation.

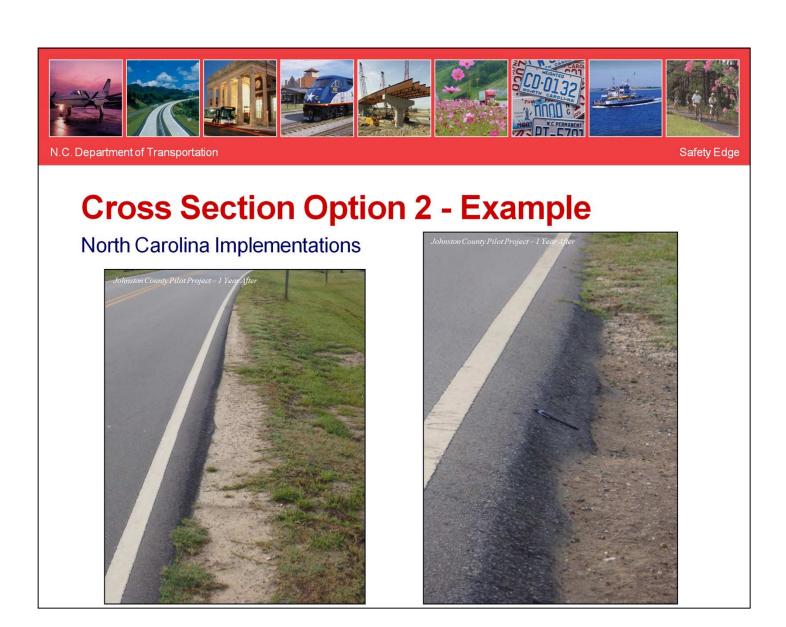
One (1) Year After Observation.
